Manhole Inspection Summary

Manhole # S39AA1003MH

Location Address: **725 34TH ST**

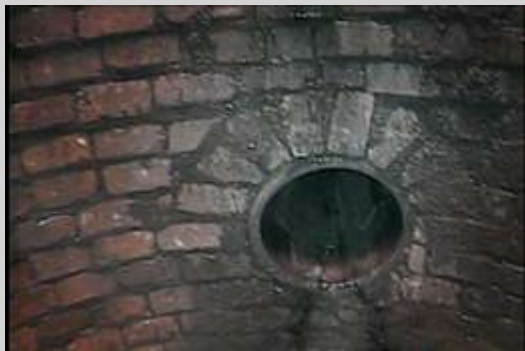
8 in. Circular Gravity Sewer
Pipe In @ 9 O'Clock

Pipe Material: **Clay** ☐ Pipe Lined

Infiltration: **None** Pipe Seal Cond: **Unknown**
